Boise Home Inspection Report

514 Wilbur Rd, Farmville, ID 12345

Inspection Date: 3/21/2014

Report Number: 140321 Zuckerman

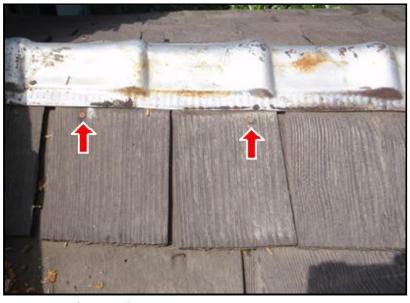
- 1.0 Item 1(Picture)
- (2) The tree limbs that are in contact with roof or hanging near roof should be trimmed.

(1) Nail heads or staples are exposed on the roof surface. They should be nailed flat and sealed during clean, dry, and warm weather. This can help to reduce the risk of leaks in the future.

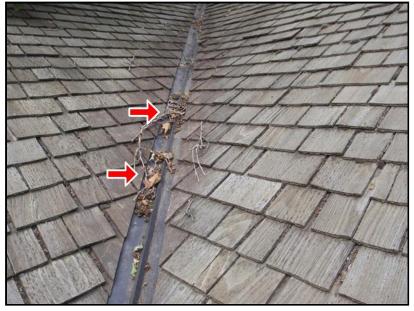
1.0 Item 3(Picture)

(3) The roof covering has debris on the roof covering at the valley. This area will need periodical maintenance. I recommend repair as desired.

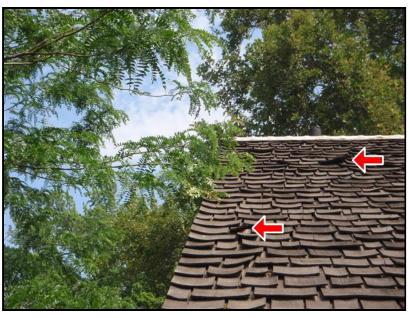
1.0 Item 4(Picture)

(4) The Roof shingles has lifted shingles at the south side. Unable to determine if this area will leak. A qualified person should repair or replace as needed.

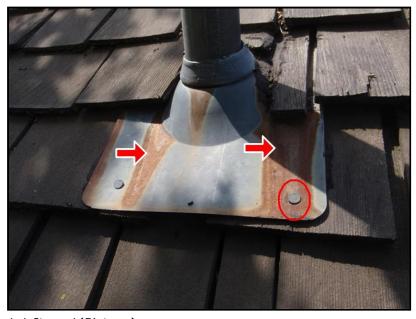
1.1 Item 1(Picture)

Nail heads or staples are exposed on the flashing. They should be nailed flat and sealed with a roof tar. This should be done during clean, dry, and warm conditions to reduce risk of leaks in the future.

Evidence of rusty was found on or around the flashing. Sealing the flashing with a self bonding paint during the surface is clean, dry, and warm is recommended to keep the flashing from leaking over time.

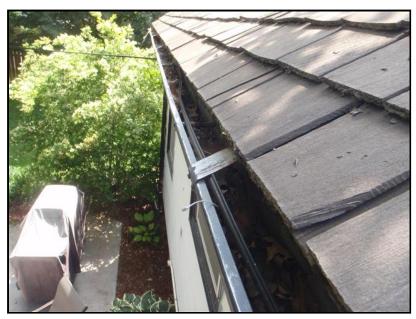
1.3 Item 1(Picture)

The gutters are full of debris in areas and needs to be cleaned. The debris in gutters can also conceal rust, deterioration or leaks that are not visible until cleaned, and I am unable to determine if such conditions exist.

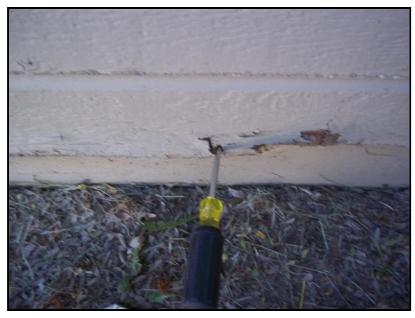
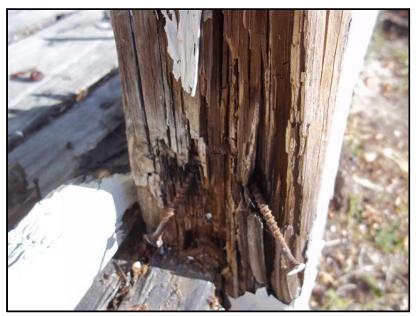
(1) The wood siding at the rear of home has a hole and has signs of wood rot. Further deterioration can occur if not corrected. A qualified person should repair or replace as needed.

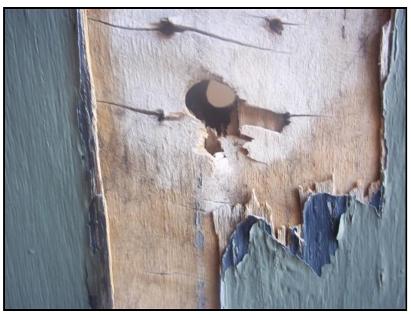
2.0 Item 3(Picture)

(2) Paint failing on siding. Needs prep and paint at exterior.

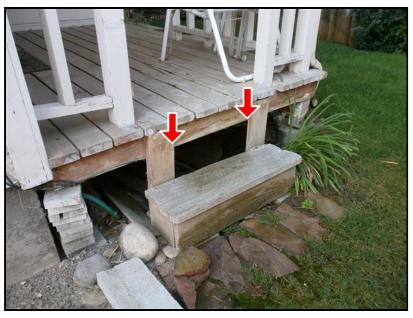
2.6 Item 1(Picture)

Step(s) are at an unsafe depth. This is a fall hazard and should be repaired to prevent injury. Recommend a licensed contractor to remove and repair.

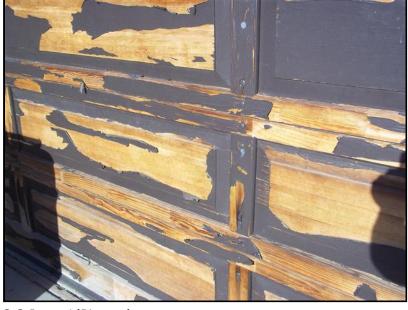
3.3 Item 1(Picture)

The two-door garage at the rear of home is weathered. This is a maintenance issue and is for your information. I recommend repair as desired.

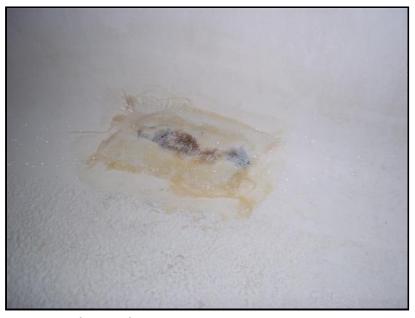
4.0 Item 1(Picture)

The Plaster on the ceiling reveals a water stain indicating a leak did or still exists at the Library room. Due to recent dry weather, I am unable to determine if the leak still exists. Monitor for and repair or replace as needed.

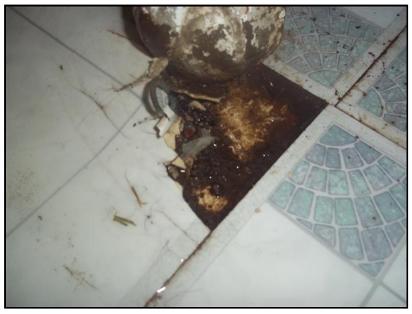
4.2 Item 1(Picture)

The vinyl tile was not installed according to standard workmanlike practices at the master bath. While this damage is cosmetic, the repair cost should be considered due to the amount of damage. A qualified person should repair or replace as needed.

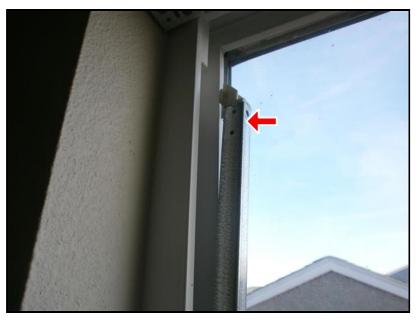
4.6 Item 1(Picture)

Windows balance spring is broken at the master bedroom and living Room. repair is needed to keep the window open or to prevent it from slamming shut. A qualified contractor should inspect and repair as needed.

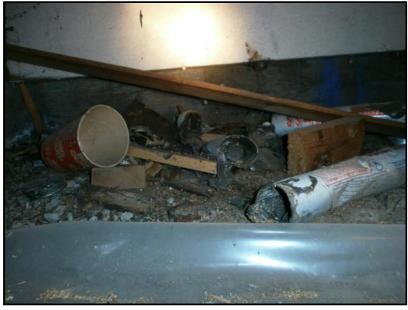
5.0 Item 1(Picture)

(1) The construction debris needs removing from the crawlspace under home.

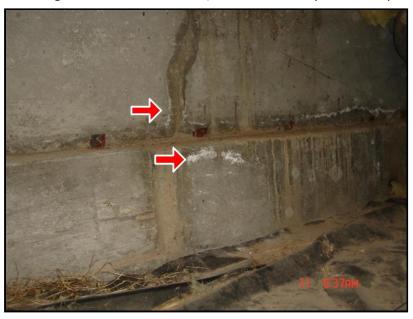
5.0 Item 2(Picture)

(2) White efflorescence (powder substance) on block wall indicates moisture is in contact with the masonry. This does not necessarily indicate that intrusion will occur. I recommend checking the gutters and the downspout drain lines for proper operation. Also, a water proofing paint could be applied to the

interior side of the block if necessary. Efflorescence is found on many homes without water intrusion occurring inside the home. But, it should alert you to the possibility that future steps may be needed.

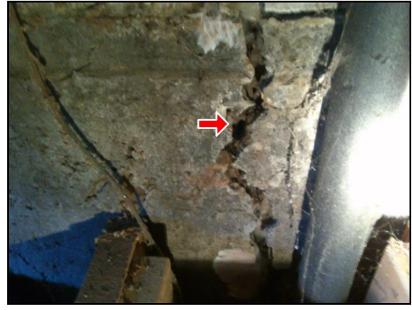
5.1 Item 1(Picture)

The foundation wall at the rear of home has a large crack. This condition can cause the wall to settle more or possibly fail. Remove improper grading, sprinklers that stray to close to the house, or extend downspouts away from the foundation to remedy this situation and A qualified licensed general contractor should inspect further and repair as needed.

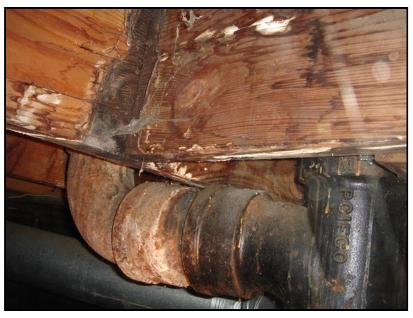
6.0 Item 1(Picture)

(1) The plumbing waste line shows signs of past/present leak in the crawlspace. Monitor for any leaks in the future. Recommend remove, repair, or replace if needed.

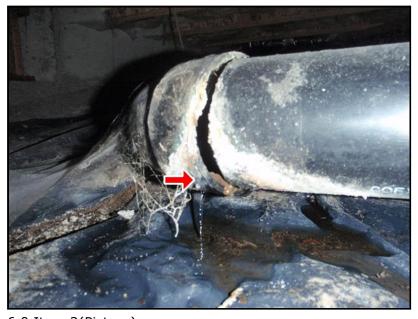
6.0 Item 2(Picture)

(2) The waste line is leaking at the Kitchen sink. Repairs are needed to prevent sewage from leaking into crawlspace. A qualified licensed plumber should repair or correct as needed.

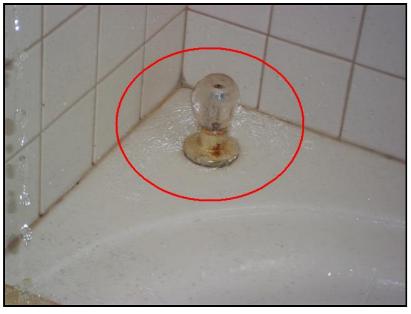
6.1 Item 1(Picture)

The control knob on faucet leaks at the tub faucet.

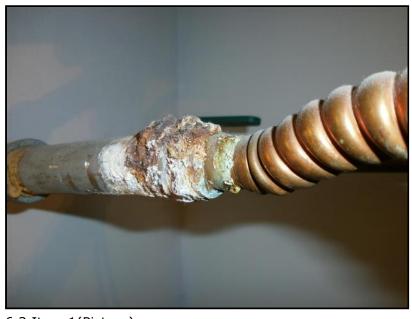
6.2 Item 1(Picture)

Above the water heater supply piping is copper and galvanized which is missing a die-electric fitting. This fitting will separate the two metals so that dialysis (corrosion/rust) does not occur in the future. All the fittings downstream of this connection prolong the life of the system.

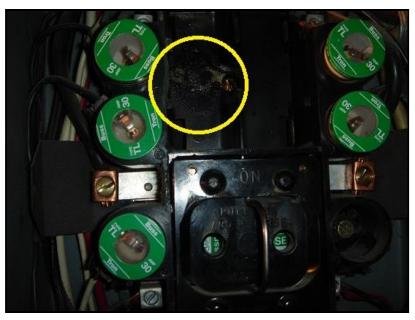
7.1 Item 1(Picture)

The problem(s) discovered in the panel such as burnt connection(s), and any other problems that an electrical contractor may discover while performing repairs need correcting. I recommend a licensed electrical contractor inspect further and correct as needed.

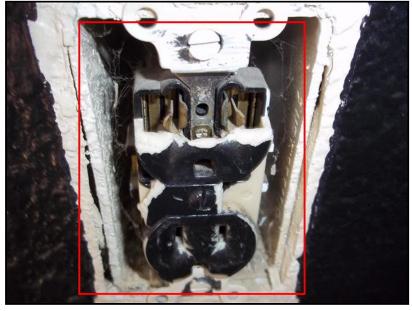
7.3 Item 1(Picture)

(1) Loose or missing cover plates should be replace to prevent a shock hazard.

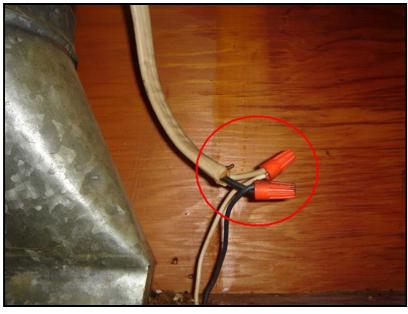
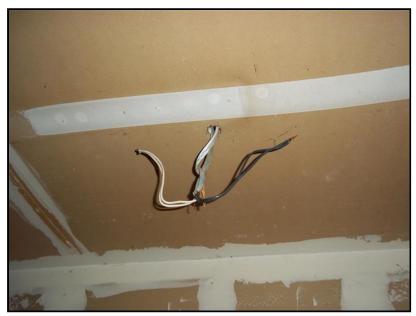
(2) Several open splices needs placing inside a box with a cover-plate in the attic space and in the crawlspace. A qualified licensed electrical contractor should perform repairs that involve wiring.

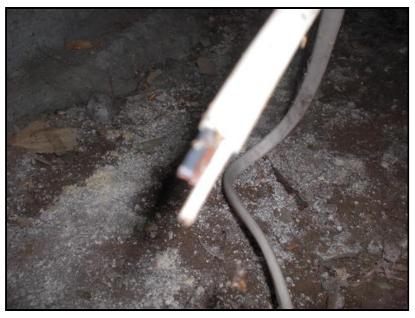
7.3 Item 4(Picture)

(3) Abandon wire in the crawlspace should be protected removed from the ground, if touching, and it should be secured in a junction box. A licensed electrician is recommended to make any electrical repairs.

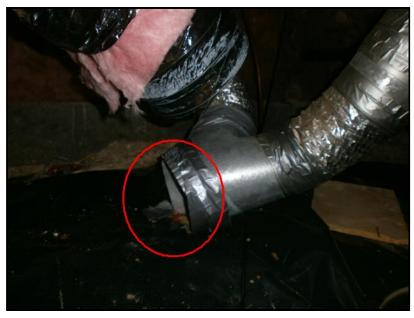
8.3 Item 1(Picture)

The supply is disconnected in the crawlspace. Besides energy loss, damage to duct pipe is large enough to allow insects or critters to enter through ductwork. A licensed HVAC contractor should service or repair unit.

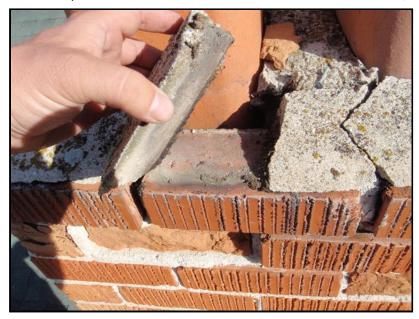
8.7 Item 1(Picture)

Brick mortar and or chimney cap has missing or deteriorating between the bricks. Further damage could be done to the fireplace and water could leak into the attic area. The appropriate type mortar is needed for this repair. Recommend a licensed contractor to remove/replace as needed.

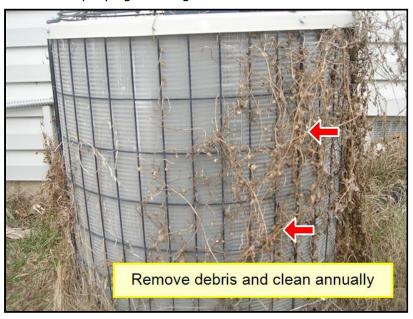
8.9 Item 1(Picture)

(1) Outdoor a/c unit is dirty. This is considered regular maintenance and should be clean annually as a minimum. Spraying with a garden hose from the inside out is recommended for the unit to run efficiently.

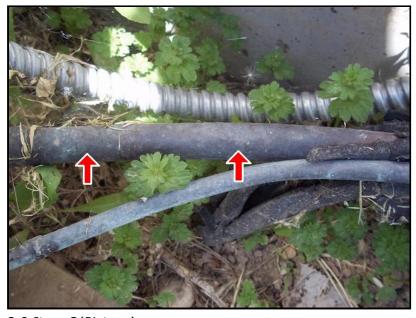
8.9 Item 2(Picture)

(2) The foam sleeve on suction line is missing foam sleeve in area(s) at outside unit. Missing foam on suction line can cause energy loss and condensation. I recommend service or repair as needed.

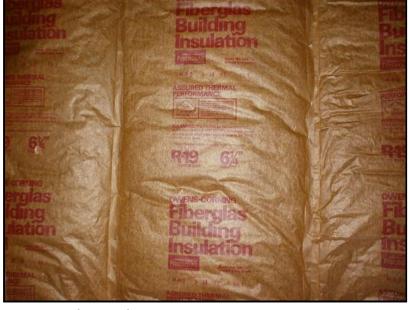
9.0 Item 1(Picture)

Insulation is installed with "paper or kraft" face up. The paper side should always face the "heated space" or condensation could occur in attic. Condensation can cause mold or wood deterioration. A qualified person should repair or replace as needed.

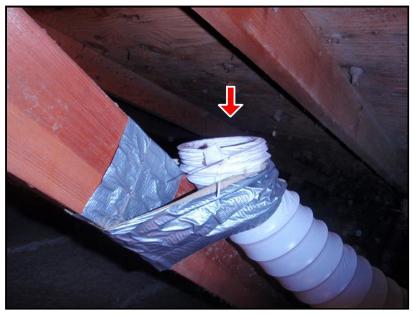
9.4 Item 1(Picture)

The exhaust fan does not vent to outside at the master bath. Vent pipes should terminate outside and not in the attic. Many homes have their vent pipe poised at the roof vent such as yours. It is up to you to determine whether or not this is a concern or needs further consideration from a general contractor. A qualified person should repair or replace as needed.

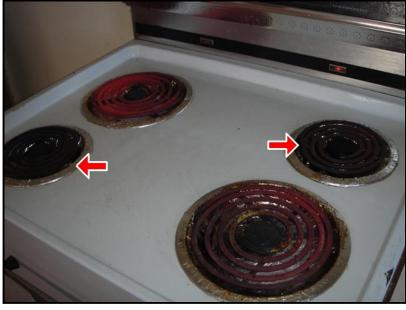
10.1 Item 1(Picture)

The front left coil element and left rear coil element for oven does not function properly. I recommend repair as needed.

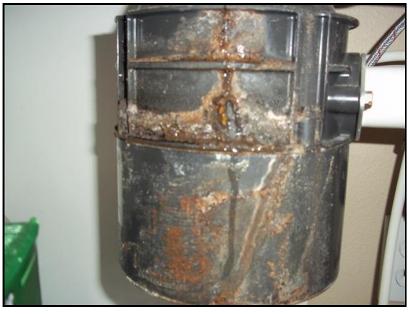
10.3 Item 1(Picture)

The food disposer is leaking. I recommend repair as needed.

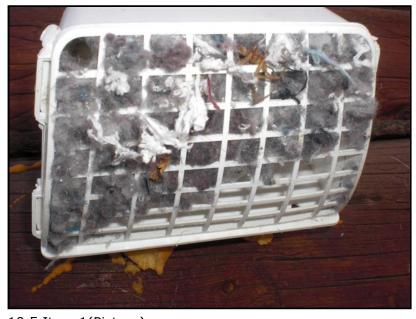
10.5 Item 1(Picture)

Dryer vent/cap is damaged, detached, or clogged. Recommend replacing as needed.
