Boise Home Inspection Report

514 Wilbur Rd, Farmville, ID 12345

Inspection Date: 3/21/2014

Report Number: 140321 Zuckerman

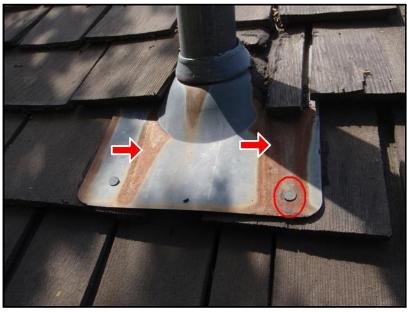
1.1 Item 1(Picture)

Nail heads or staples are exposed on the flashing. They should be nailed flat and sealed with a roof tar. This should be done during clean, dry, and warm conditions to reduce risk of leaks in the future.

Evidence of rusty was found on or around the flashing. Sealing the flashing with a self bonding paint during the surface is clean, dry, and warm is recommended to keep the flashing from leaking over time.

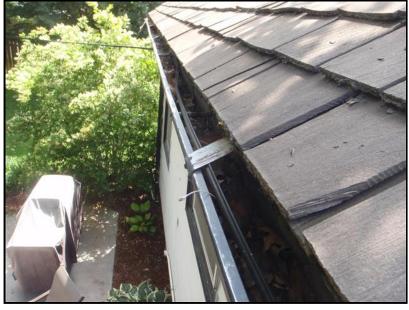
1.3 Item 1(Picture)

The gutters are full of debris in areas and needs to be cleaned. The debris in gutters can also conceal rust, deterioration or leaks that are not visible until cleaned, and I am unable to determine if such conditions exist.

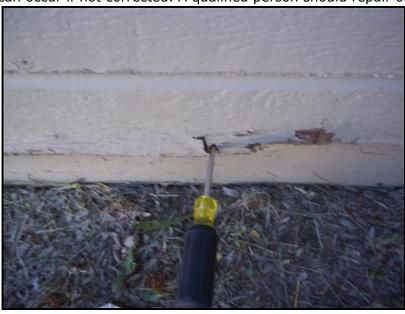
2.0 Item 1(Picture)

(1) The wood siding at the rear of home has a hole and has signs of wood rot. Further deterioration can occur if not corrected. A qualified person should repair or replace as needed.

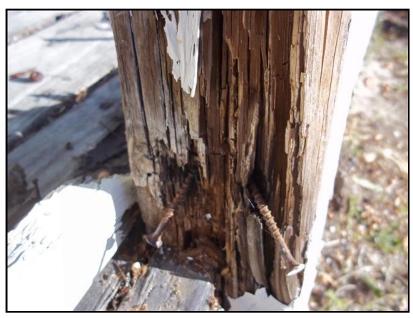
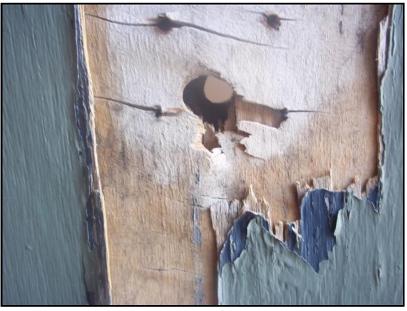
(2) Paint failing on siding. Needs prep and paint at exterior.

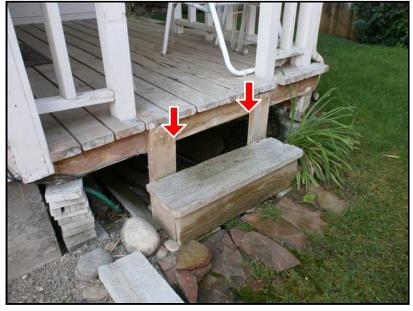
2.6 Item 1(Picture)

Step(s) are at an unsafe depth. This is a fall hazard and should be repaired to prevent injury. Recommend a licensed contractor to remove and repair.

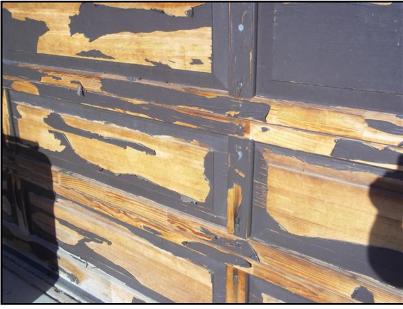
3.3 Item 1(Picture)

The two-door garage at the rear of home is weathered. This is a maintenance issue and is for your information. I recommend repair as desired.

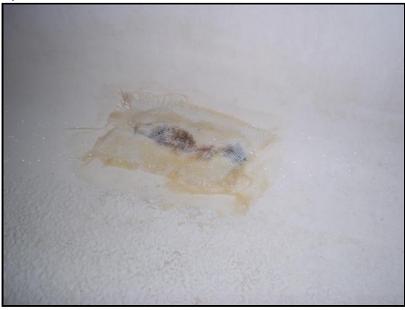
4.0 Item 1(Picture)

The Plaster on the ceiling reveals a water stain indicating a leak did or still exists at the Library room. Due to recent dry weather, I am unable to determine if the leak still exists. Monitor for and repair or replace as needed.

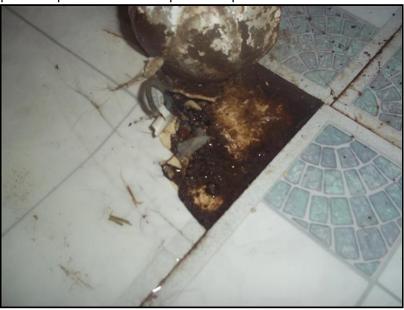
4.2 Item 1(Picture)

The vinyl tile was not installed according to standard workmanlike practices at the master bath. While this damage is cosmetic, the repair cost should be considered due to the amount of damage. A qualified person should repair or replace as needed.

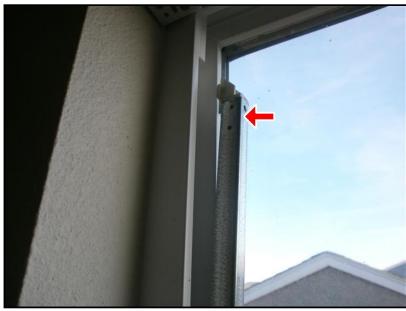
4.6 Item 1(Picture)

Windows balance spring is broken at the master bedroom and living Room. repair is needed to keep the window open or to prevent it from slamming shut. A qualified contractor should inspect and repair as needed.

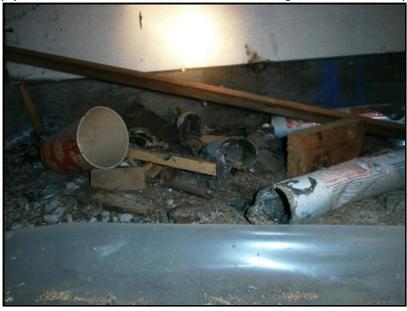
5.0 Item 1(Picture)

(1) The construction debris needs removing from the crawlspace under home.

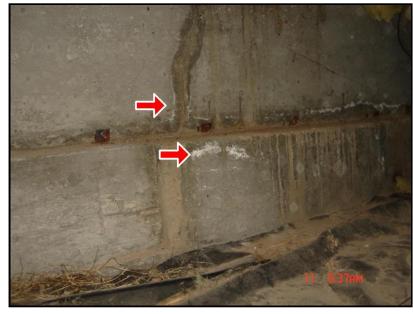
5.0 Item 2(Picture)

(2) White efflorescence (powder substance) on block wall indicates moisture is in contact with the masonry. This does not necessarily indicate that intrusion will occur. I recommend checking the gutters and the downspout drain lines for proper operation. Also, a water proofing paint could be applied to the

interior side of the block if necessary. Efflorescence is found on many homes without water intrusion occurring inside the home. But, it should alert you to the possibility that future steps may be needed.

(2) White efflorescence (powder substance) on block wall indicates moisture is in contact with the masonry. This does not necessarily indicate that intrusion will occur. I recommend checking the gutters and the downspout drain lines for proper operation. Also, a water proofing paint could be applied to the interior side of the block if necessary. Efflorescence is found on many homes without water intrusion occurring inside the home. But, it should alert you to the possibility that future steps may be needed.

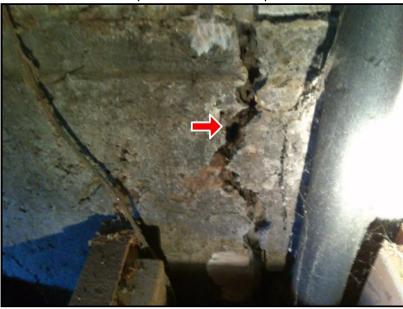
5.1 Item 1(Picture)

The foundation wall at the rear of home has a large crack. This condition can cause the wall to settle more or possibly fail. Remove improper grading, sprinklers that stray to close to the house, or extend downspouts away from the foundation to remedy this situation and A qualified licensed general contractor should inspect further and repair as needed.

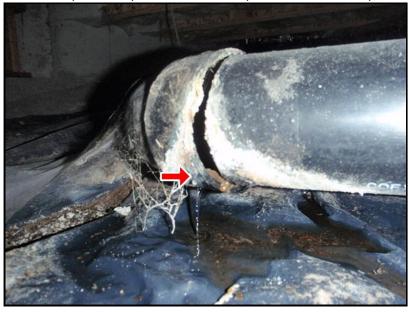
6.0 Item 2(Picture)

(2) The waste line is leaking at the Kitchen sink. Repairs are needed to prevent sewage from leaking into crawlspace. A qualified licensed plumber should repair or correct as needed.

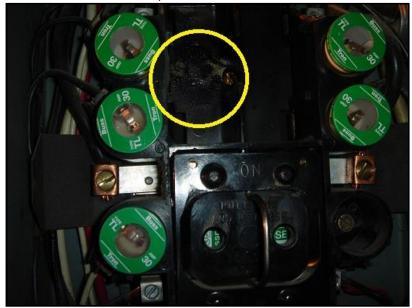
7.1 Item 1(Picture)

The problem(s) discovered in the panel such as burnt connection(s), and any other problems that an electrical contractor may discover while performing repairs need correcting. I recommend a licensed electrical contractor inspect further and correct as needed.

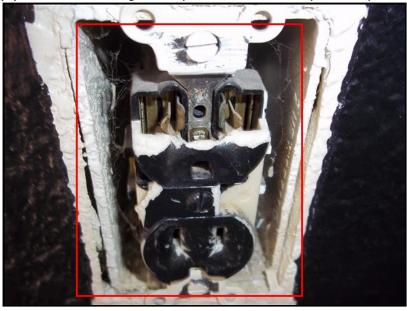
7.3 Item 1(Picture)

(1) Loose or missing cover plates should be replace to prevent a shock hazard.

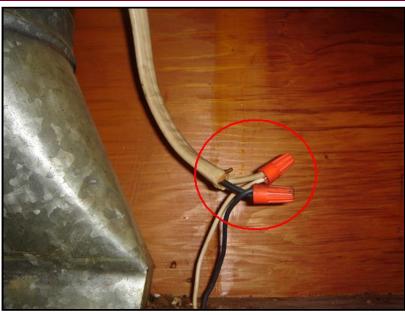
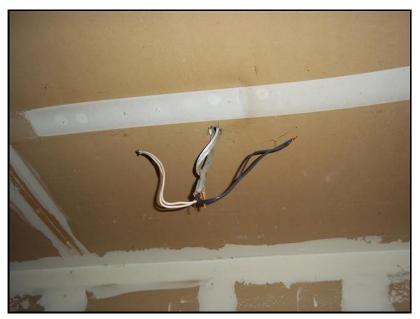
(2) Several open splices needs placing inside a box with a cover-plate in the attic space and in the crawlspace. A qualified licensed electrical contractor should perform repairs that involve wiring.

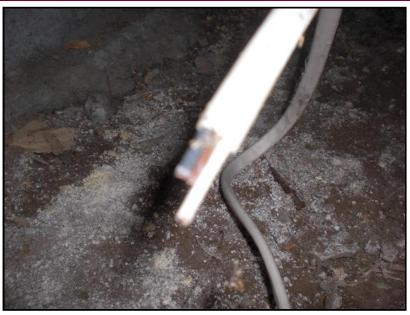
7.3 Item 4(Picture)

(3) Abandon wire in the crawlspace should be protected removed from the ground, if touching, and it should be secured in a junction box. A licensed electrician is recommended to make any electrical repairs.

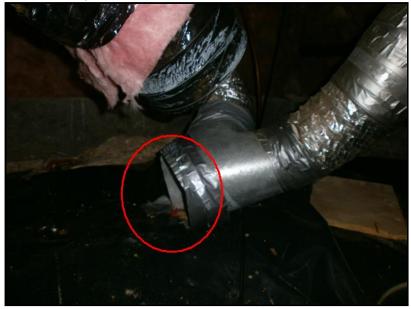
8.3 Item 1(Picture)

The supply is disconnected in the crawlspace. Besides energy loss, damage to duct pipe is large enough to allow insects or critters to enter through ductwork. A licensed HVAC contractor should service or repair unit.

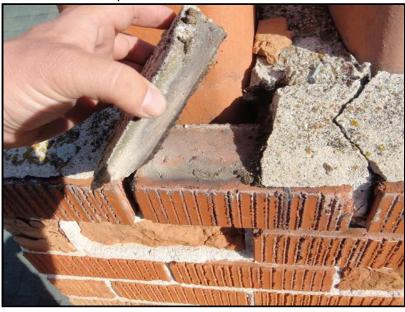
8.7 Item 1(Picture)

Brick mortar and or chimney cap has missing or deteriorating between the bricks. Further damage could be done to the fireplace and water could leak into the attic area. The appropriate type mortar is needed for this repair. Recommend a licensed contractor to remove/replace as needed.

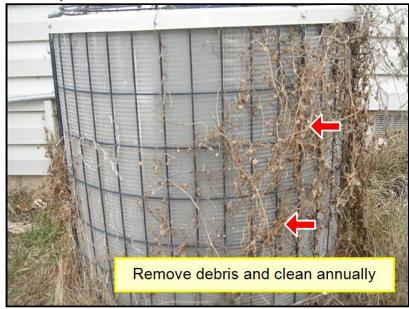
8.9 Item 1(Picture)

(1) Outdoor a/c unit is dirty. This is considered regular maintenance and should be clean annually as a minimum. Spraying with a garden hose from the inside out is recommended for the unit to run efficiently.

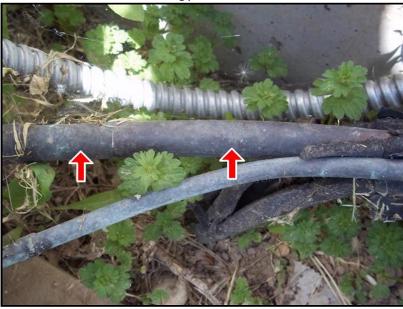
8.9 Item 2(Picture)

(2) The foam sleeve on suction line is missing foam sleeve in area(s) at outside unit. Missing foam on suction line can cause energy loss and condensation. I recommend service or repair as needed.

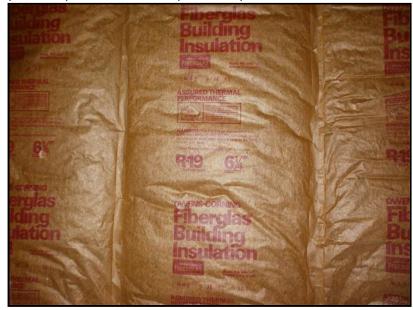
9.0 Item 1(Picture)

Insulation is installed with "paper or kraft" face up. The paper side should always face the "heated space" or condensation could occur in attic. Condensation can cause mold or wood deterioration. A qualified person should repair or replace as needed.

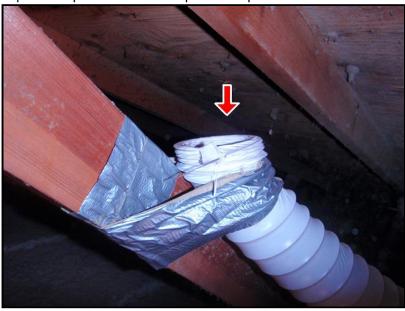
9.4 Item 1(Picture)

The exhaust fan does not vent to outside at the master bath. Vent pipes should terminate outside and not in the attic. Many homes have their vent pipe poised at the roof vent such as yours. It is up to you to determine whether or not this is a concern or needs further consideration from a general contractor. A qualified person should repair or replace as needed.

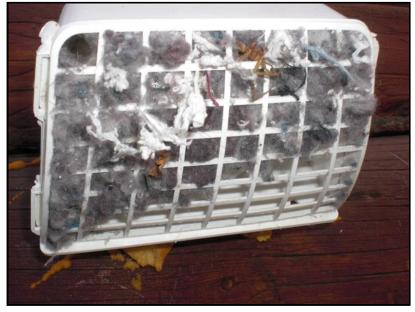
10.5 Item 1(Picture)

Dryer vent/cap is damaged, detached, or clogged. Recommend replacing as needed.
